A RESERVE STUDY UPDATE FOR

**San Simeon Phase 1
Residents' Association, Inc.
Commons
Fort Myers, Florida
File # 22920-06249**

FOR PERIOD: January 1, 2017 – December 31, 2017

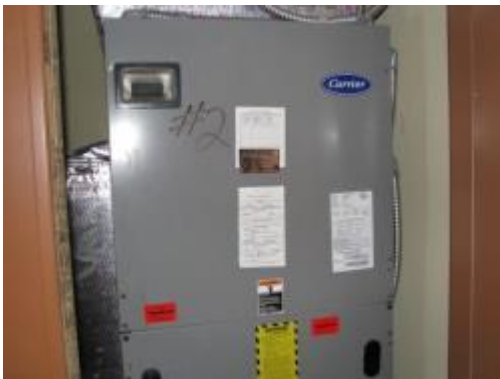
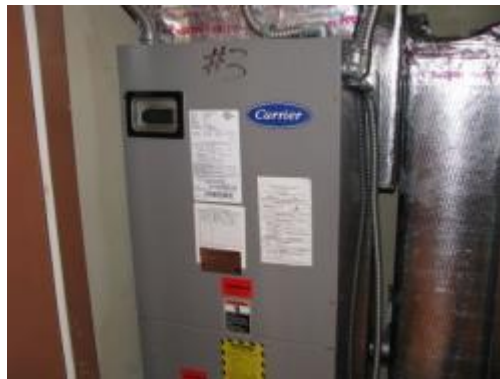
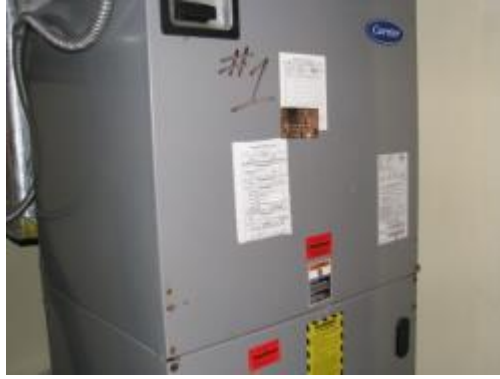
Because they may not require replacement concurrently, reserves for the individual air conditioning air handlers supporting the clubhouse interiors were included. Outside an ocean environment, a life cycle in the 20-year range range is the market norm we have observed for replacement of split HVAC air handlers, assuming proper and routine maintenance.

Changes to building codes since the 2006 installation date of these units have mandated that at the next condenser unit replacement, the corresponding air handler must also be replaced so that both are brought up to more efficient, code compliant use. The remaining useful lives of the air handlers were adjusted to reflect similar replacement dates as their corresponding condensers. Recurring 20-year life cycles were forecast thereafter.

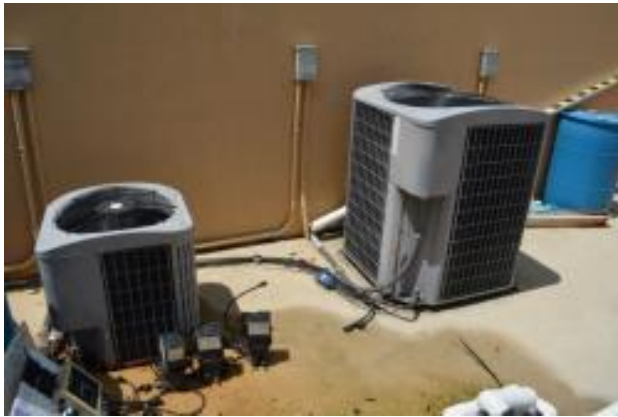
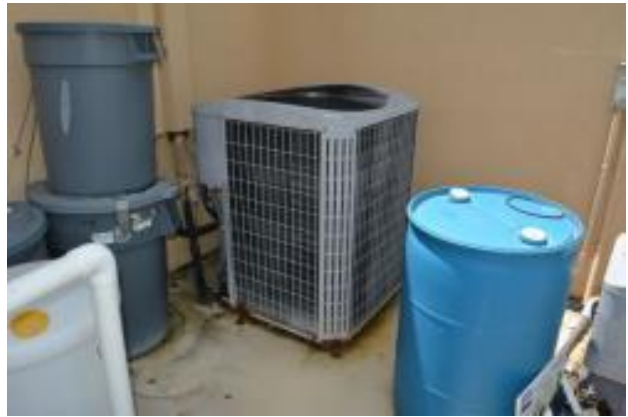
Outside an ocean environment, life cycles in the low to mid-10-year range have been observed for replacement of residential/commercial grade split HVAC condenser units like those supporting the clubhouse interiors. As they may not require replacement concurrently, a line item was included for each.

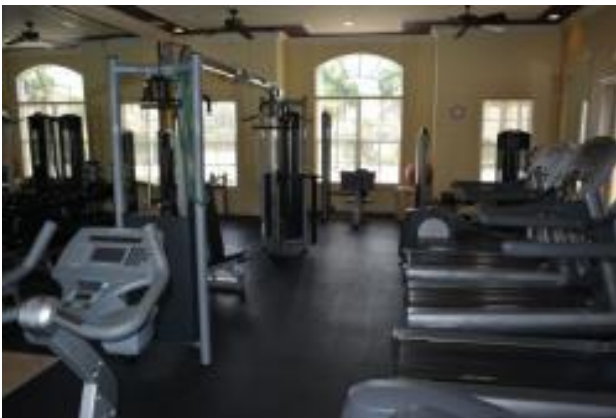
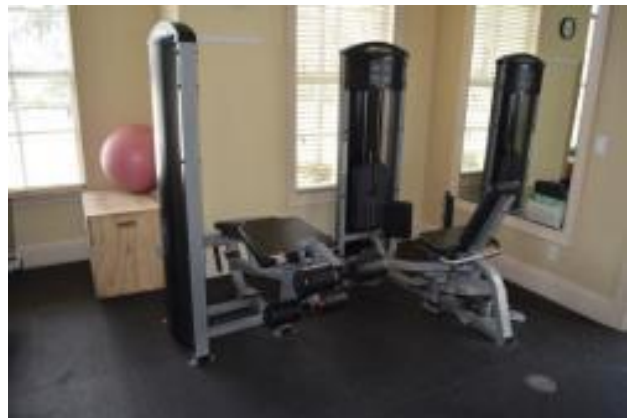
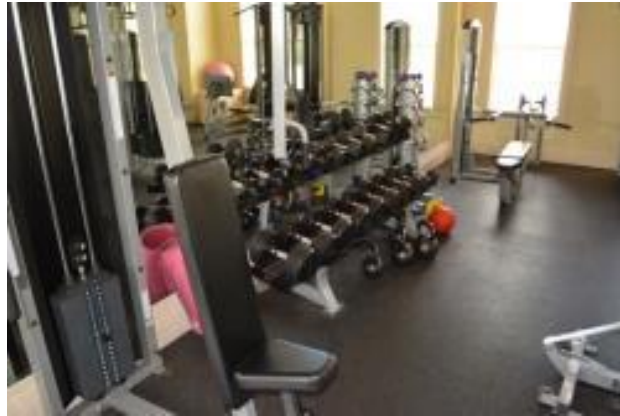
It is our market observation that while minor additions and/or replacements can be expected from time to time, better quality properties complete exercise equipment inventory replacements (treadmills, elliptical trainers, upright and recumbent exercise bikes, arc trainers, strength training stations, etc.) on a life cycle in the 10-12-year range, to insure the modern, appealing equipment is in use. This fund is designed to provide monies for as needed exercise equipment replacements, flooring, wall mirrors/finishes, etc. in the clubhouse exercise room over a recurring 12-year life cycle. The association representative has advised that the replacement of the gym equipment will occur in fiscal year 2019. The current lump sum cost estimate is an order of magnitude figure based on the size and quality of the existing inventory and size of the exercise room.

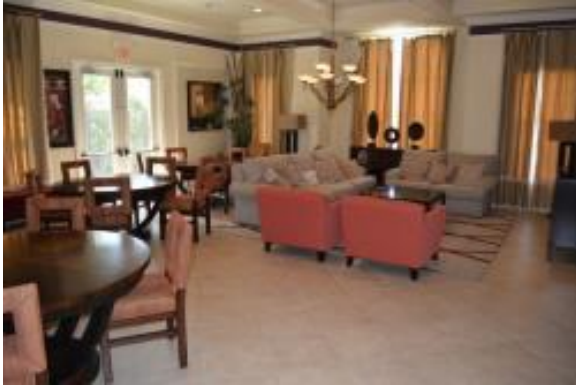
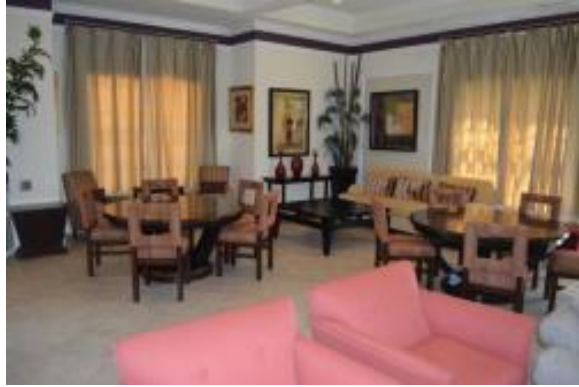
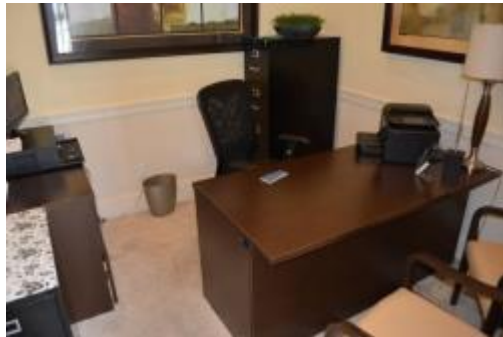
To insure a modern cosmetic appeal, the association should expect to complete major common area furnishings/finishes projects on a periodic and regular basis. Included are sofas, chairs, window treatments, wall and door finishes, area rugs/carpeting, tables, lamps/decorative lighting, plants, etc. While minor additions/replacements/upgrades can be expected from time to time, a life cycle in the low to mid 10-year range is the market norm we have observed. A 14-year life cycle estimate reflects a 2020 expense date for major clubhouse interior furnishings/finishes upgrades. The current \$/square foot unit cost is an order of magnitude estimate based on actual market data we have observed in buildings of similar overall quality.

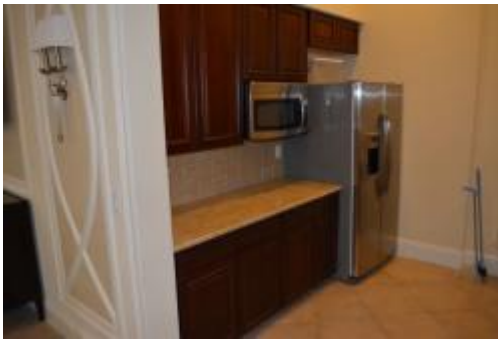
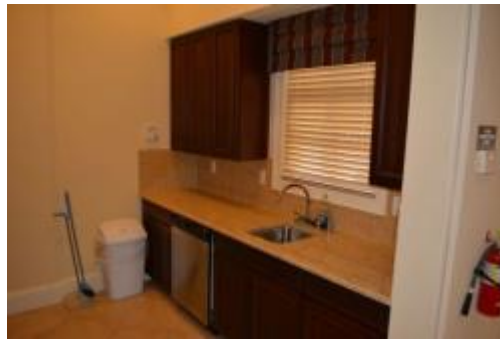
At some point in the foreseeable future, the association should expect to incur costs for major restoration of the common area kitchen (including, but not necessarily limited to, flooring, wall finishes, cabinetry and counters, plumbing and electrical fixtures, etc.). Life cycles of less than 15 years, to 30+ years, have been observed in properties of similar quality. A 20-year life cycle reflects a 2026 renovation date for the clubhouse kitchen. The current cost estimate does not include any unforeseen floor area reconfiguration and/or expansion.

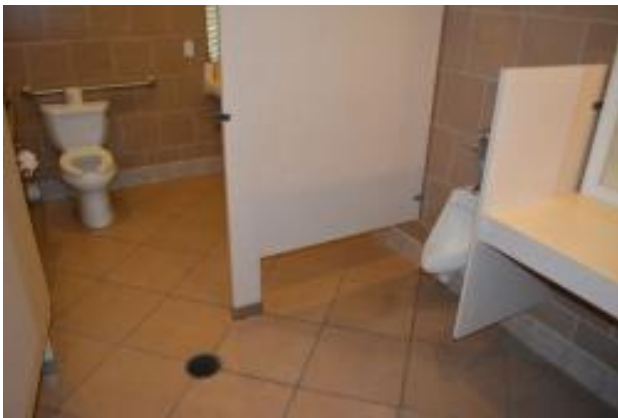
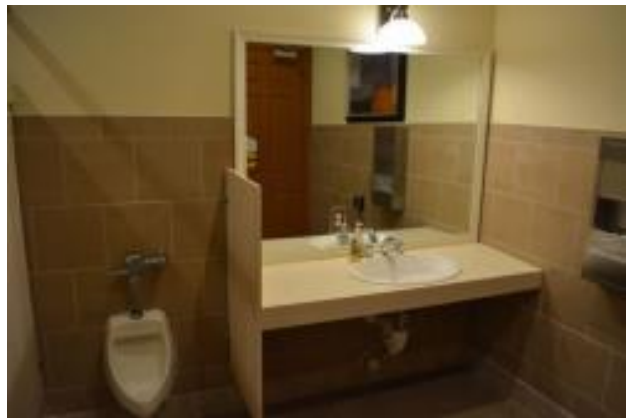
Our inspection revealed that repairs to the clubhouse restroom wall coverings should be completed in the near future, which is a function of routine maintenance. At some point in the foreseeable future, the association should expect to incur costs for major restoration of the common area restroom interiors (including, but not necessarily limited to, flooring, wall finishes, vanities, mirrors, dividers, plumbing and electrical fixtures, etc.). Life cycles of less than 15 years, to 30+ years, have been observed in properties of similar quality. A 20-year life cycle estimate reflects a 2026 restroom renovation date. The current cost estimate does not include any unforeseen floor area reconfiguration and/or expansion.

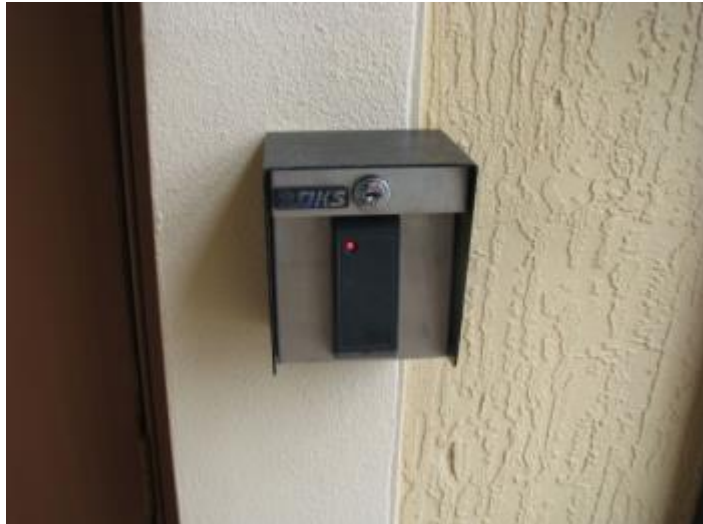
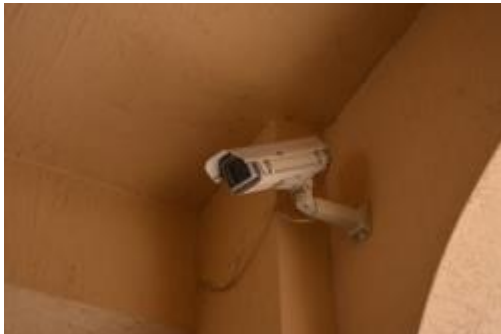
The clubhouse/common area security system includes an entry fob system and video surveillance cameras. While minor component repairs/replacements can be expected from time to time as a function of routine maintenance, it is our market observation that system modernization/replacement should be expected on a life cycle in the 10-12-year range. A 2026 expense date was forecast for this project, given the reported 2016 system upgrades.

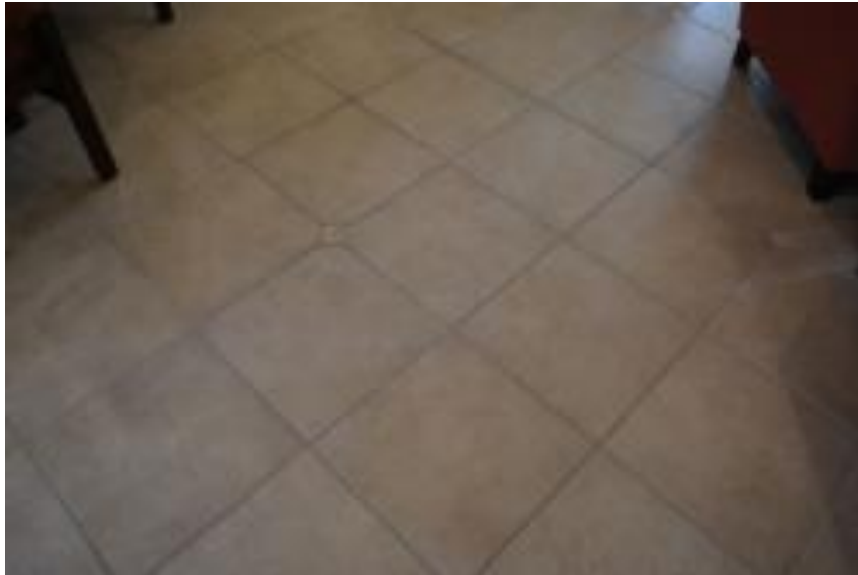
At some point in the foreseeable future, the association should expect to incur costs for replacement of their common area tile flooring. Because replacement is typically completed due to cosmetic dissatisfaction rather than physical wear out/failure of the flooring itself, life cycles can vary from property to property. We have observed life cycles of less than 10 years, to over 30 years, for replacement of tile flooring. The current cost estimate includes removal and disposal of the existing tile flooring and installation with like quality.

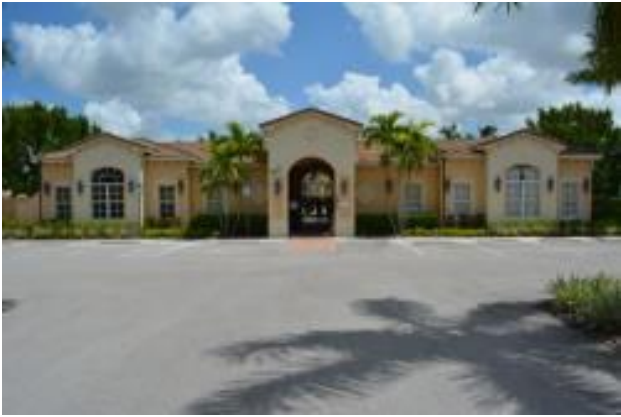
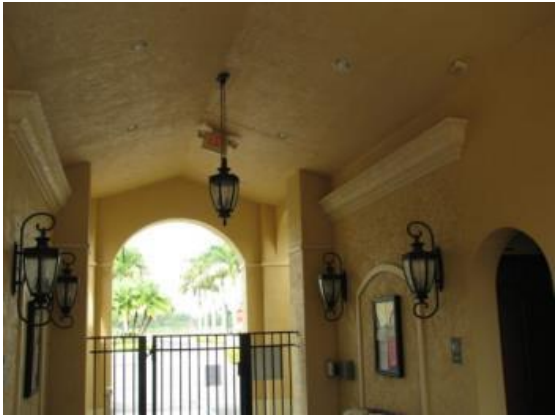
To insure proper protection of the underlying concrete, stucco, wood and metal surfaces, the market reflects a maximum 7-year useful life for exterior painting & waterproofing (in lieu of an association purchased 10-year warranty). The clubhouse exteriors were repainted in fall 2012, and a 2019 expense date was forecast accordingly. The current average per dwelling unit cost estimate includes typical minor concrete/stucco repairs, surface preparation, as needed caulking and painting/refinishing of all exterior concrete, stucco, wood and metal surfaces.

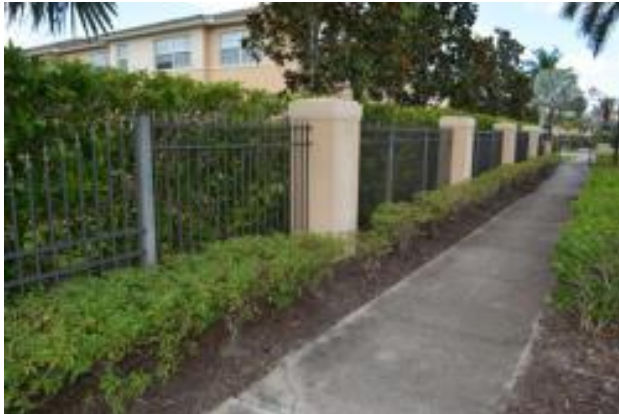
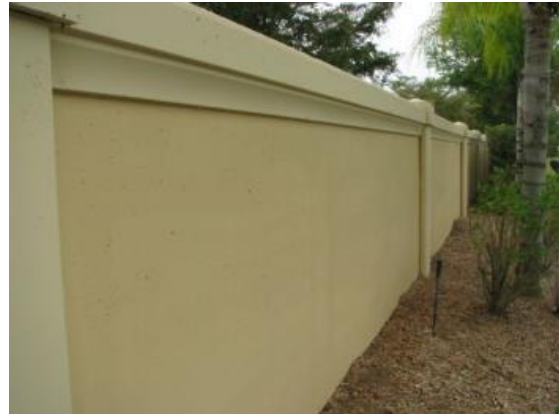
To insure proper protection of the underlying concrete, stucco, wood and metal surfaces, the market reflects a maximum 7-year useful life for exterior painting & waterproofing (in lieu of an association purchased 10-year warranty). The perimeter wall along the east property boundary and fencing monuments were repainted in fall 2012, and a 2019 expense date was forecast accordingly. The current cost estimate includes typical minor concrete/stucco repairs, and surface preparation, and is based on the approximate height and linear footage of the wall and monument count/sizes.

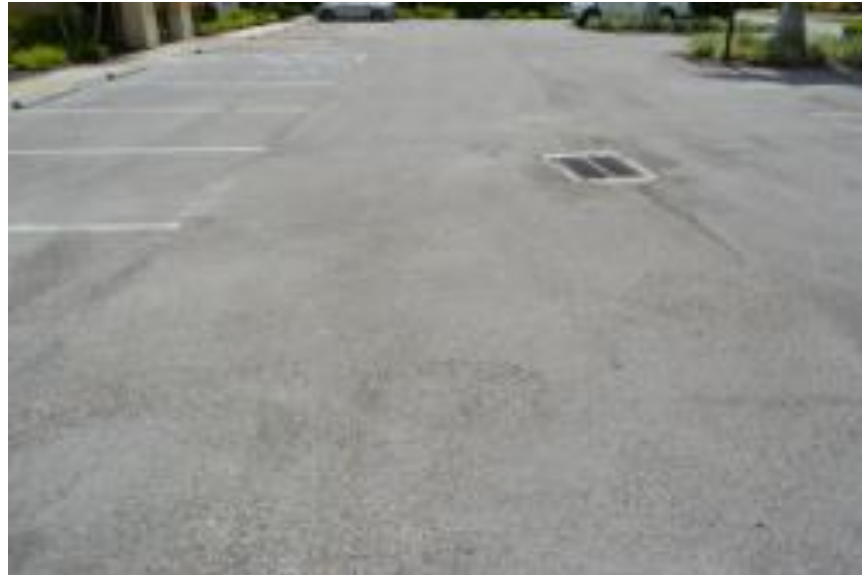
We have observed life cycles of less than 15 years, to 25+ years, for asphalt overlay projects, assuming proper design, installation and routine maintenance. The asphalt paving was installed in late 2012; utilizing a 20-year life cycle estimate, this project was forecast in 2032. The current unit cost estimate includes as needed milling of the asphalt paving at its junction with adjacent concrete paving, typical minor repairs to the underlying pavement subbase and drainage systems, installation of a standard overlay, and re-striping. The paved area is a rounded estimate.

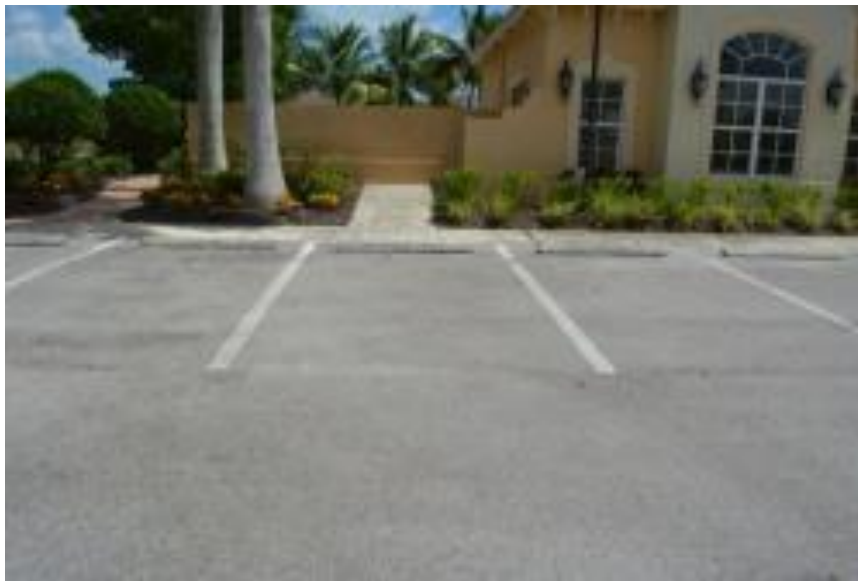
Sealcoating/rejuvenation serves as not only a cosmetic upgrade; it also insures minimal moisture intrusion into the underlying pavement structure. Without a proper moisture barrier, premature deterioration in the form of potholes, etc. can occur, causing the need for more frequent (and costly) asphalt overlays. The market reflects a typical useful life of 3-4 years for this upgrade, and that to insure the maximum useful life of asphalt paving, should be completed within the first year of a new overlay project. As there were no reported plans to complete this project in 2016, a 2017 expense date was scheduled. A recurring 4-year life cycle was scheduled thereafter. The current cost estimate includes typical minor pavement repairs and re-stripping.

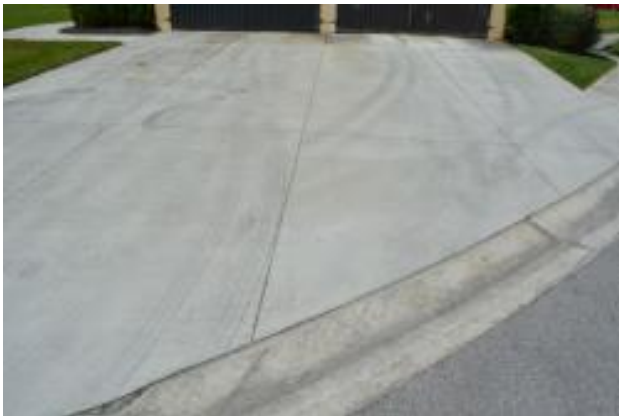
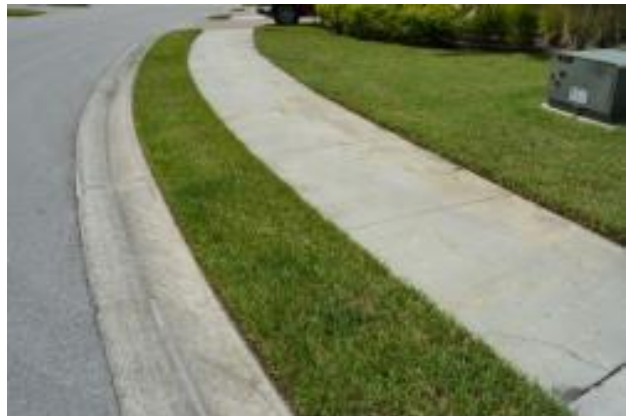
Under normal conditions, total replacement of concrete paving (sidewalks, curbing, gutters, etc.) should not be necessary at any one given time. It is our market observation that while some associations do establish and fund contingency reserves for concrete paving repairs, many prefer to fund as needed repairs through their annual operating budgets, as a function of routine maintenance. At the association's request and sole discretion, a line item was included to provide \$20,000 for as needed common area concrete paving repairs/replacements over a recurring 10-year life cycle. This fund is a contingency only; actual costs and time frames may vary, perhaps widely, from these estimates.

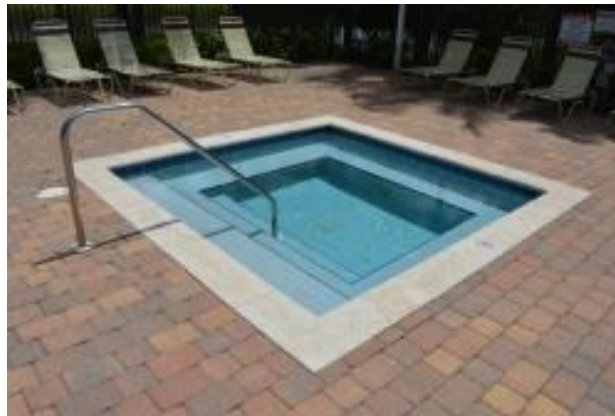
Some associations consider paver parking and drives, sidewalks, pool and spa decks, etc. to be effectively permanent, and opt to exclude replacement from their annual reserve budgets. Others do establish and fund reserves, on observed budgetary life cycles of 20-40 years. It is our opinion that reserving for eventual replacement is prudent, if only for cosmetic purposes; we have observed older pavers that appear worn and dated, even with periodic pressure washing and/or sealing. This reserve is designed to provide monies for as needed repairs to and eventual replacement of the paver decking at the pool, spa, and clubhouse walkways over a 24-year life cycle. The total area is a rounded estimate.

Of note was the report that some of the paver areas were becoming uneven, which could represent a trip and fall hazard. We recommend that the association complete needed repairs in the near future, accordingly.

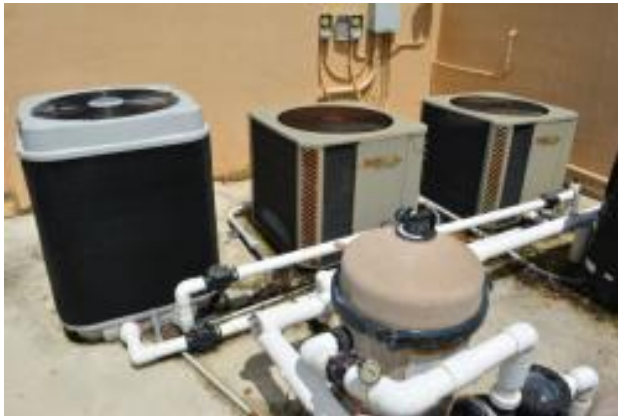
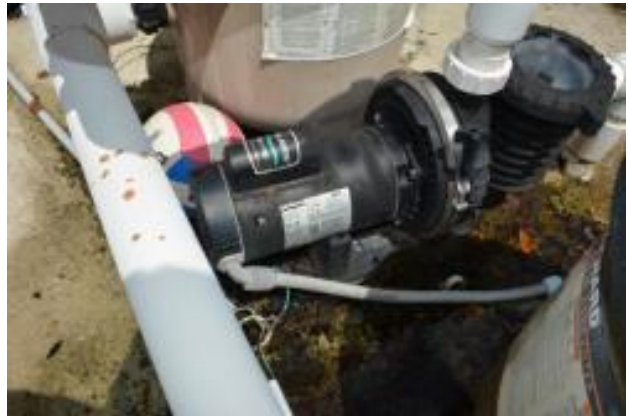
Under normal conditions, total replacement of pool and spa equipment inventories (pumps, motors, chlorination systems, filters, heaters, etc.) should not be necessary at any one given time. As such, reserving for total replacement is not considered prudent or practical. This is supported by our review of reserve budgets at similar properties; while some associations establish and fund contingency reserves for as needed repair/replacement costs, others prefer to fund incidental expenses through their annual operating budgets, as a function of routine maintenance. For the association's consideration, and given its inclusion in the association's fiscal year 2013 reserve budget, we have included an allowance to provide monies for as needed pool and spa equipment expenses over a recurring 12-year life cycle. This fund is a projection only; actual costs and time frames may vary from our estimates.

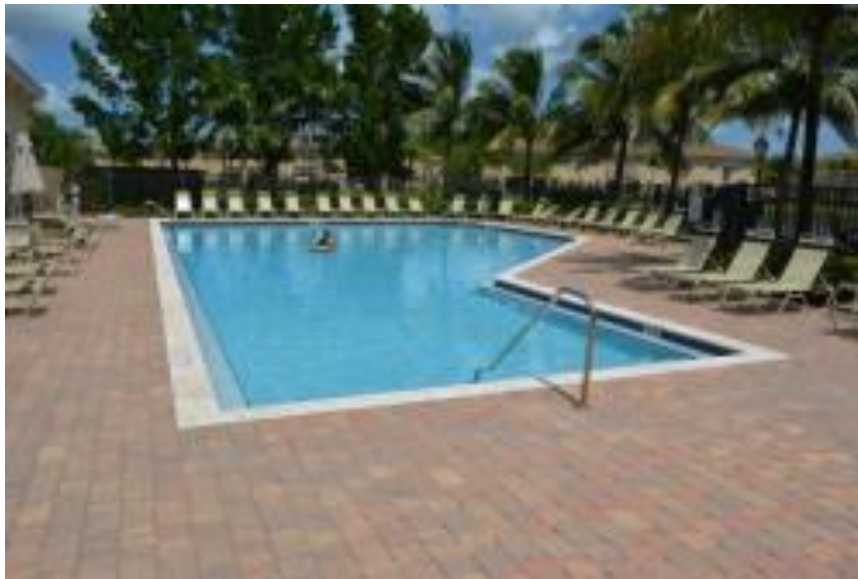
While minor additions/replacements can be expected from time to time, and assuming periodic as needed re-strapping and/or refinishing as a function of routine maintenance, most associations complete pool deck furniture inventory replacements on a 7-10-year life cycle. This fund is designed to provide monies for as needed pool and spa deck furniture replacements (chaise lounges, tables, chairs, umbrellas, trash receptacles, etc.) over a 10-year life cycle. No replacement has been reported, therefore the 2016 date for scheduled replacement has been adjusted to 2017.

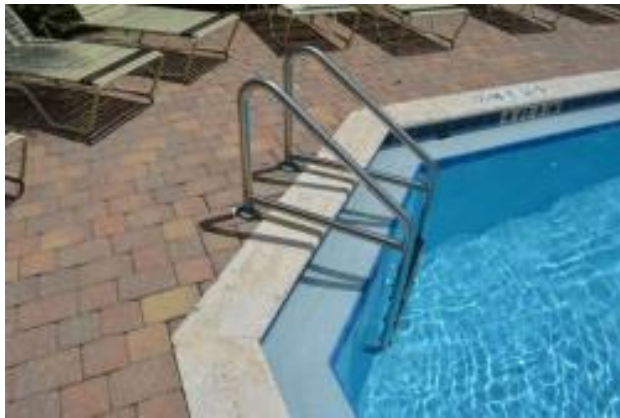
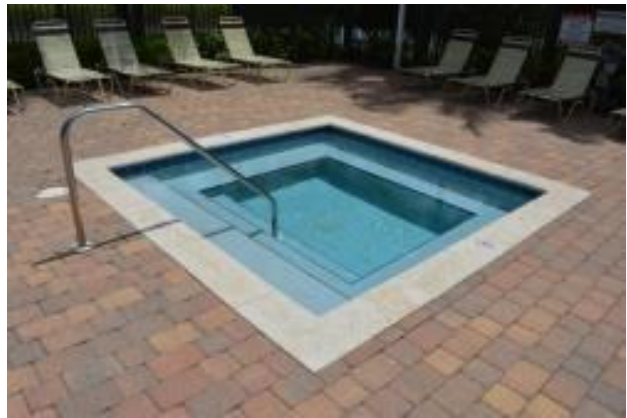
Assuming proper installation, chemical balancing, and routine maintenance, interior resurfacing of standard concrete pools and spas with marcite or aggregate interior finishes should be expected on a life cycle in the 10-12-year range. Resurfacing of the +/- 2,140 square foot, 58,144-gallon pool and +/- 90 sq., 1,456-gallon spa was forecast in 2016. however, per the association representative a refurbishment date has been approved for fiscal year 2017. We have set the useful life on a 12 year recurring cycle. The current per square foot of surface area cost estimate includes typical minor tank/structural repairs, tile upgrades and/or replacements, and installation of new aggregate surface materials (i.e. "diamond brite", "pebble crete", etc.).

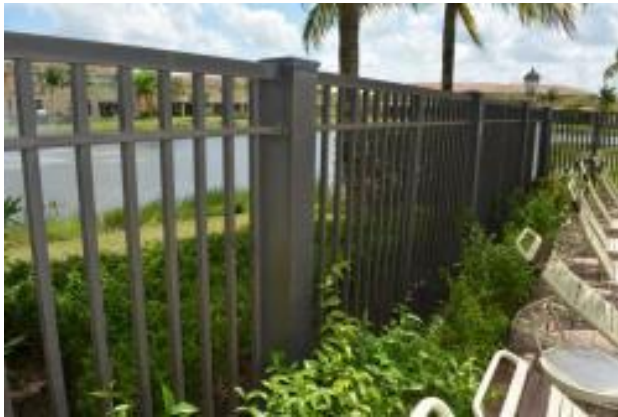
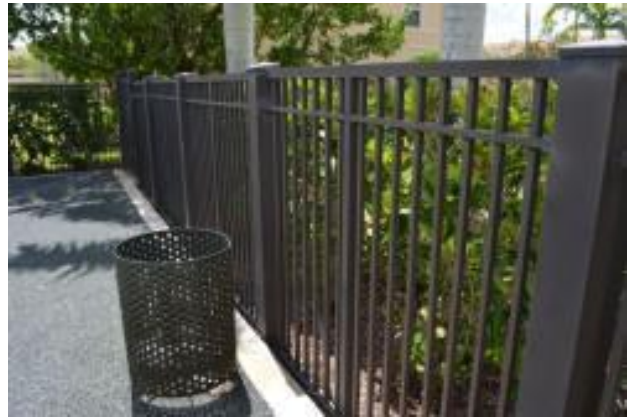
A life cycle in the low to mid 20-year range is the most typical useful life we have observed for replacement of standard aluminum pool/spa deck fencing and gates. The pool and tot lot fencing and gates were forecast for replacement in 2030, accordingly. The current per linear foot cost estimate includes removal and disposal of the existing fencing and gates and installation of like height/quality fencing and gates.

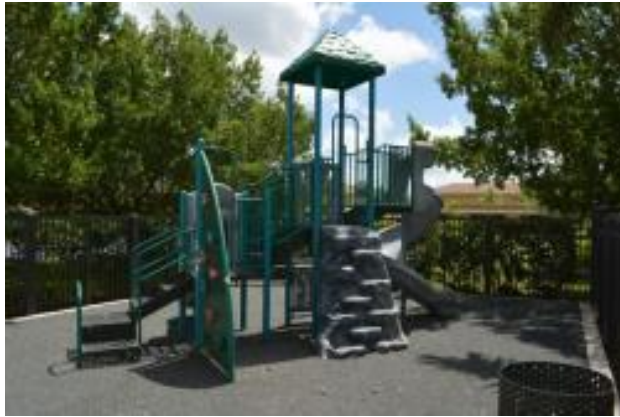
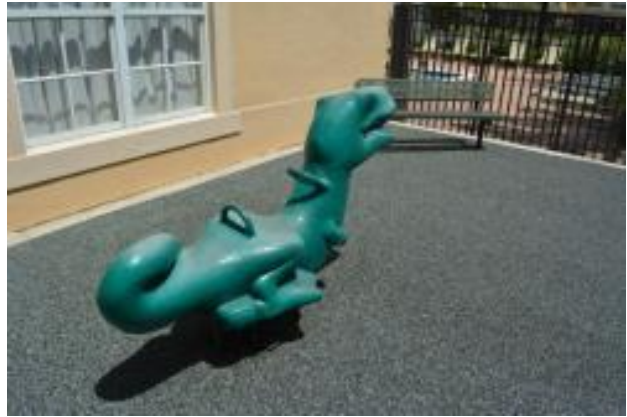
To insure a modern appeal, tot lot equipment replacement should be expected on a life cycle in the 10-12-year range. The existing equipment and decking was observed to be in average to good overall condition, and a 2018 replacement date forecast.

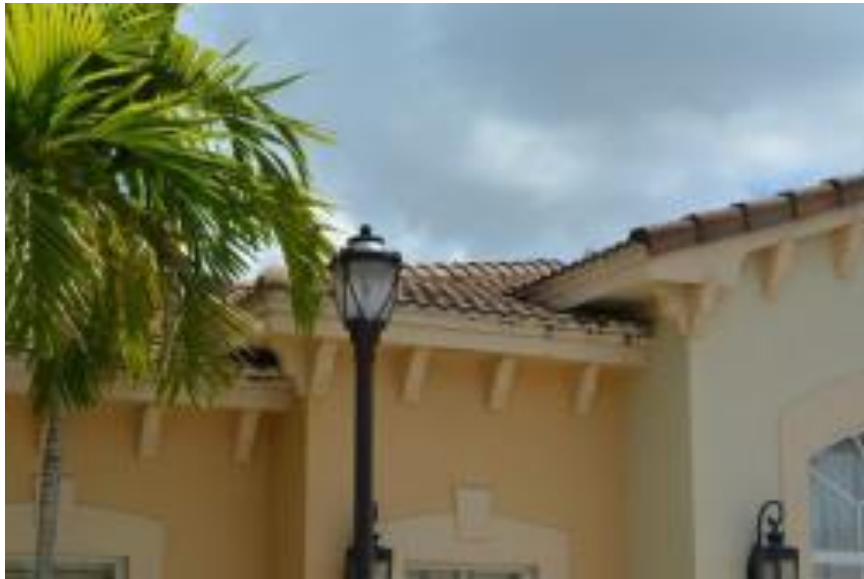
Life cycles of less than 20 years, to 35+ years, have been observed for replacement of pitched tile roofing; the most typical life falls in the mid 20-year range, assuming proper design, installation and routine maintenance. As no professional roofing studies were provided that would indicate that physical conditions exist at this roofing that would otherwise limit its remaining useful life, a 2031 replacement date was forecast for replacement of the clubhouse roof. The current cost estimate includes removal and disposal of the existing roofing, typical minor repairs to the underlying roof structures, flashing, as needed repair/replacement of fascia, soffits etc., and installation of like roofing.

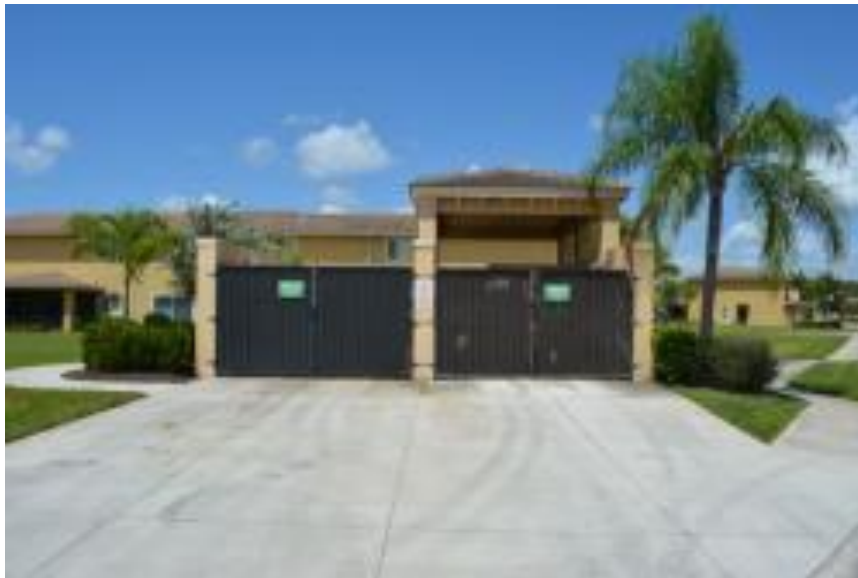
Life cycles of less than 20 years, to 35+ years, have been observed for replacement of pitched tile roofing; the most typical life falls in the mid 20-year range, assuming proper design, installation and routine maintenance. As no professional roofing studies were provided that would indicate that physical conditions exist at this roofing that would otherwise limit its remaining useful life, a 2031 replacement date was forecast for the compactor building tile roofing. The current cost estimate includes removal and disposal of the existing roofing, typical minor repairs to the underlying roof structures, flashing, as needed repair/replacement of fascia, soffits etc., and installation of like roofing.

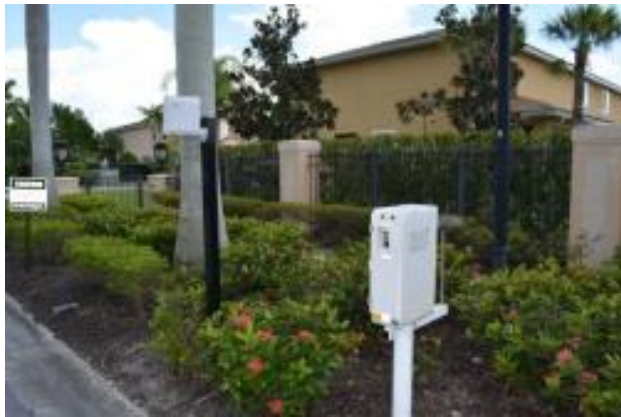
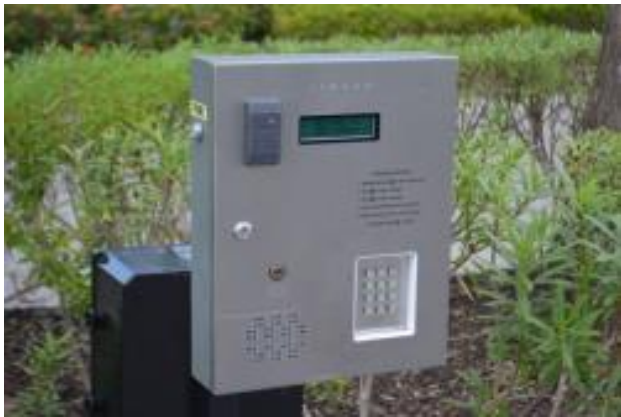
Access to the property is via an automatic vehicular transponder system and enterphone/keypad. While minor repairs/replacements can be expected from time to time as a function of routine maintenance, modernization/replacement of these access systems has been observed on life cycles in the mid to high 10-year range. Assuming installation during completion of the phase 2 Horton unit residential buildings, this expense was forecast in 2028. The current cost includes the transponder, keypad, hardware, software, etc.

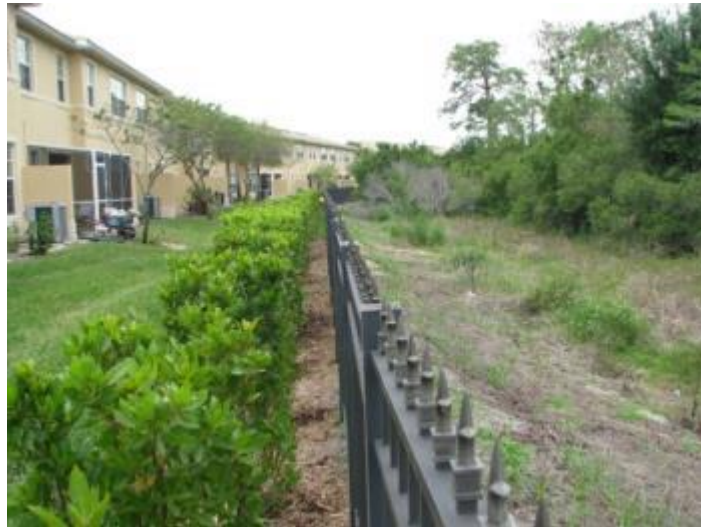
Data gleaned from the provided property records indicates that there is a total of +/- 1,858 linear feet of decorative metal perimeter fencing, which was assumed to be original to the 2006 construction of the phase 1 improvements. Under normal conditions, a life cycle in the 25-30+ year range has been observed for replacement of similar fencing, and a 2033 replacement date forecast accordingly. The current per linear foot unit cost estimate includes removal and disposal of the existing fencing and installation of like quality/height fencing.

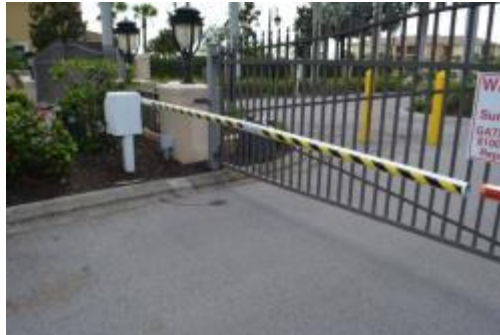
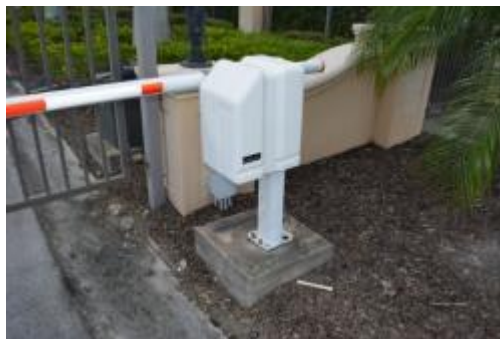
Barring any unforeseen vehicular damage, and assuming proper and routine maintenance, replacement of automatic barrier gate operators has a market observed life cycle in the low to mid-10-year range. The two exit barrier gate operators were assumed to be original to the property, while aerial maps suggest that the entry barrier gate operators were installed during construction of the phase 2 Horton residential buildings. Separate line items were included for each gate operator, accordingly. The photographs are of representative barrier gate operators.

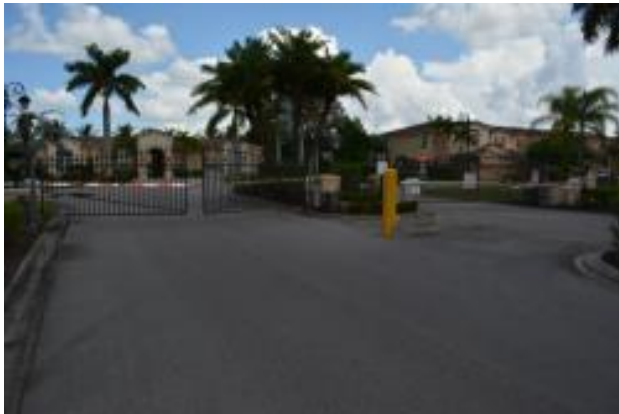
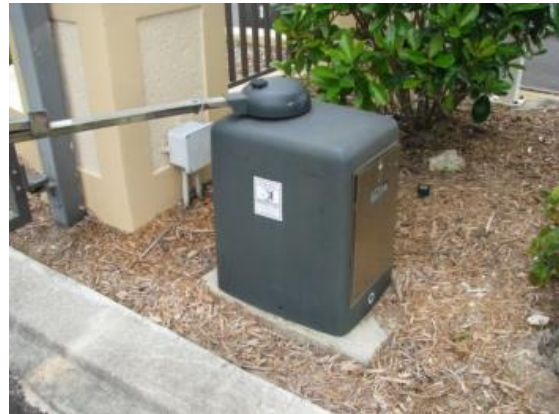
Barring any unforeseen vehicular damage, and assuming proper and routine maintenance, replacement of automatic swing gate operators has a market observed life cycle in the low to mid-10-year range. The two exit barrier gate operators were assumed to be original to the property, while aerial maps suggest that the entry barrier gate operators were installed during construction of the phase 2 Horton residential buildings. Separate line items were included for each gate operator, accordingly.

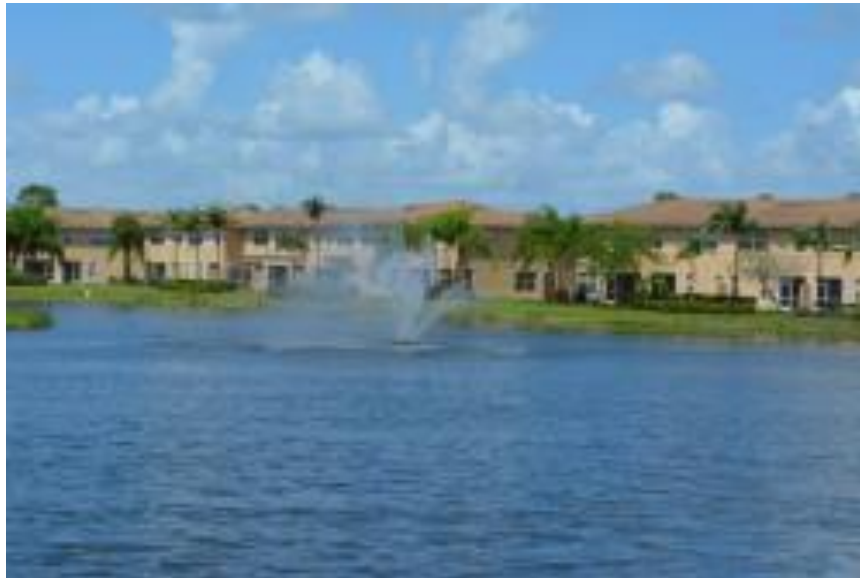
Life cycles for replacement of lake fountains suggest a probable life cycle in the mid-10 to 20-year range, under normal conditions. This fund is designed to provide monies for as needed repairs to the fountain, pumps, equipment, etc. and replacement of the lake fountain over a recurring 16-year life cycle.

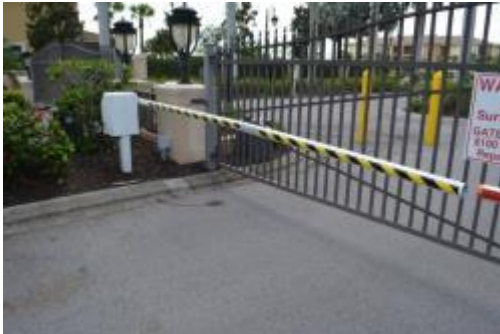
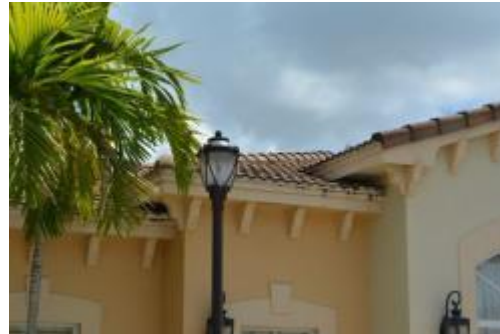
Replacement of the decorative light fixtures at the marquee signage and entry (16) and decorative light posts/fixtures at the clubhouse parking (11) should be expected on a life cycle in the low to mid-20-year range. A 2030 inventory replacement date was forecast. The total cost estimate is based on a unit cost of \$580.20 for the 16 light fixtures and \$2,565.60 for the 11 posts/fixtures.

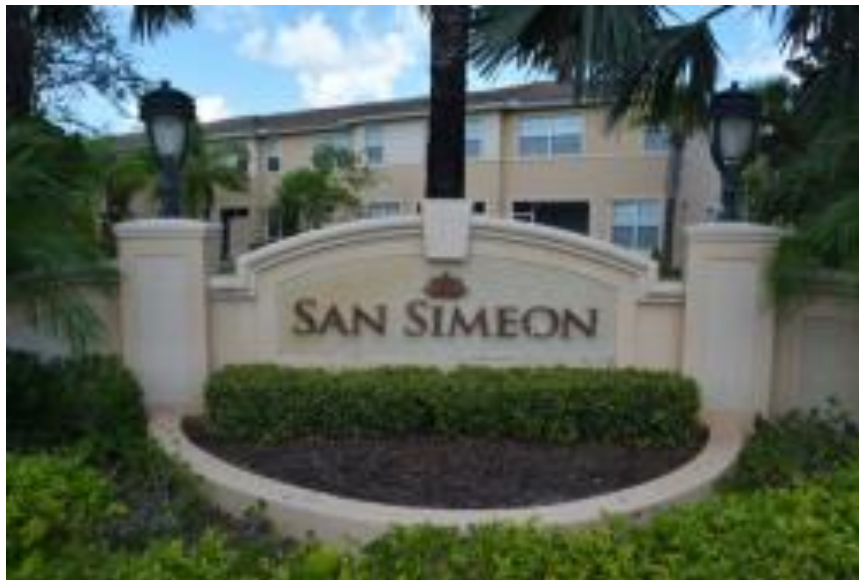
Under normal conditions, replacement of the concrete block/structure marquee signs should not be necessary in the foreseeable future. It is our market observation that associations often prefer to complete cosmetic restoration of this type of signage (lettering, facade/finish, lighting, etc.) to maintain a modern appeal, rather than raze and replace, and that this scope of renovation should be expected on a life cycle in the mid-10-year range. A 2021 expense date was forecast, accordingly.

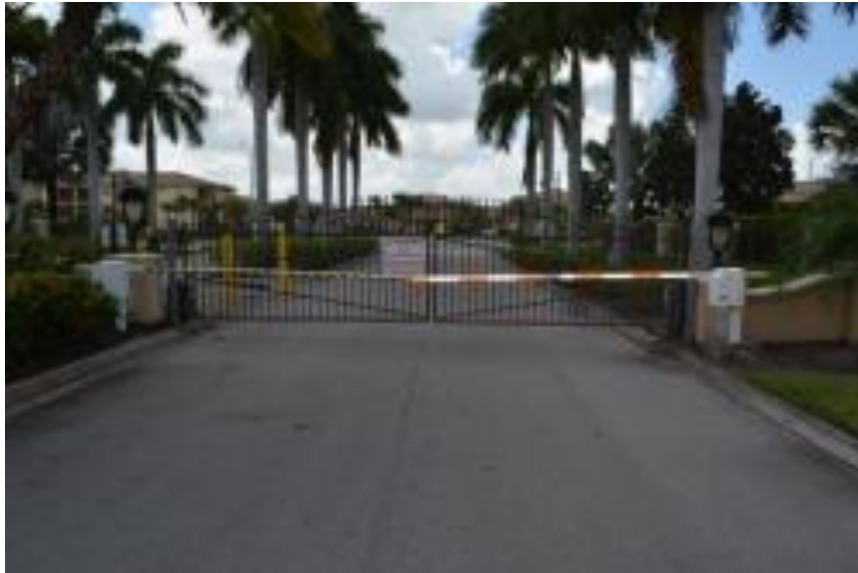
Barring any unforeseen vehicular damage, replacement of the decorative metal swing gates at the proper entry and exit should be expected on a life cycle in the low to mid-20-year range. The two exit swing gates were assumed to be original to the property, while aerial maps suggest that the entry swing gates were installed during construction of the phase 2 Horton residential buildings. Separate line items were included for each gate, accordingly.
